DYNAMIC TESTS OF AN ENERGY ABSORBING BARRIER EMPLOYING SAND-FILLED FRANGIBLE PLASTIC BARRELS

RESEARCH REPORT

NO. M&R HRB 636405-4

Prepared in Cooperation with the U.S. Department of Transportation, Federal Highway Administration January, 1972

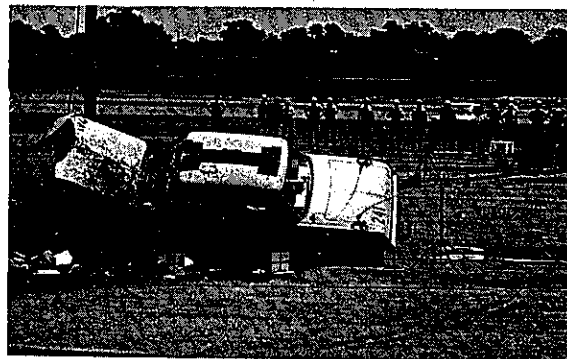
FIGURE 7

See Plate 3, page 15, for a summary of the test results. The vehicle, traveling 58 mph, impacted the barrier head-on and plowed through the entire barrier (Figures 5 and 6). The vehicle axis was one ft. to the left of the barrier axis at the time of impact. About 3-4 feet in front of the bridge railing, the vehicle ramped up on barrier debris and came to rest on the bridge rail just in front of the camera tower 24 ft behind the nose of the barrier. As it ramped up, the vehicle tilted sharply in a counterclockwise direction, since the left front wheel was off the bridge rail, and almost turned over (Figure 7) before returning to its final position. The left rear fender was flush with the ground when the vehicle came to rest.

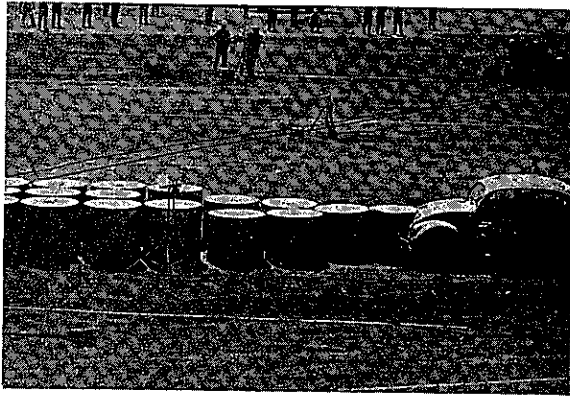
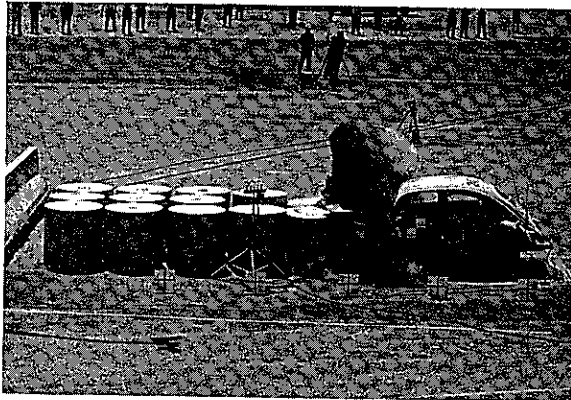
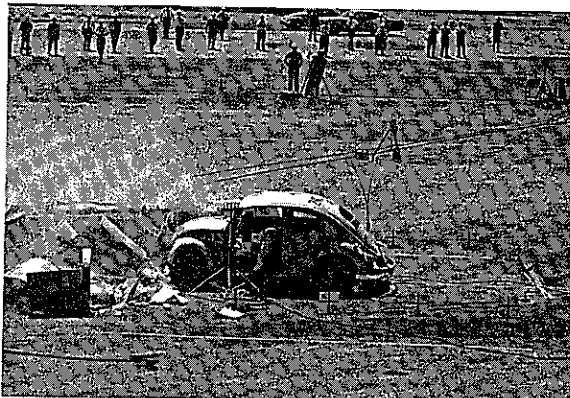
Vehicular lateral decelerations (2 accelerometers) were about 2 G's maximum for 5 ms with one ms ringing spikes of 8-10 G's. The seat belt force transducer was inoperable. The Gadd Severity Index was computed to be 1280, significantly greater than the critical value of 1000.

Test No. 242
Date of Test September 4, 1970
Vehicle 1957 Volkswagen Sedan
Vehicle Weight 1940 lbs.
(w/dummy & instrumentation)
Impact Velocity (V_0) 59.0 mph
Impact Angle Head-on
Dummy Restraint Lap belt
Barrier Depth 25'-3"
No. of Plastic Barrels 17

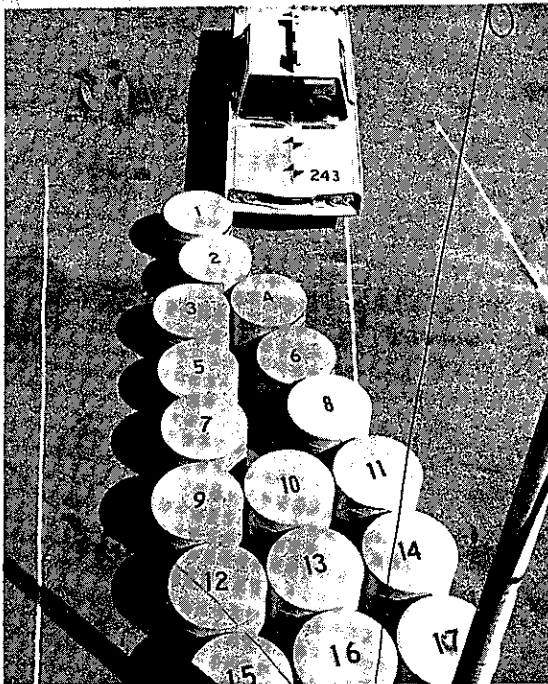
FIGURE 14

The test barrier had the same size, number, and configuration of barrels as was used for Test 242 (Figures 14-16). As in Test 242, the sand was dried prior to delivery. It had a density of 89.2 pcf and a moisture content of 0.8%.

Lids were attached to the barrels with four equidistant pop-rivets according to the manufacturer's directions. Three extra rivets were added in a short row next to one of these four rivets. This row of rivets was randomly located and was not on the same side of all the barrels. It was hoped that these extra rivets would provide a hinge effect and minimize the wide scattering of lids that occurred during Test 241.

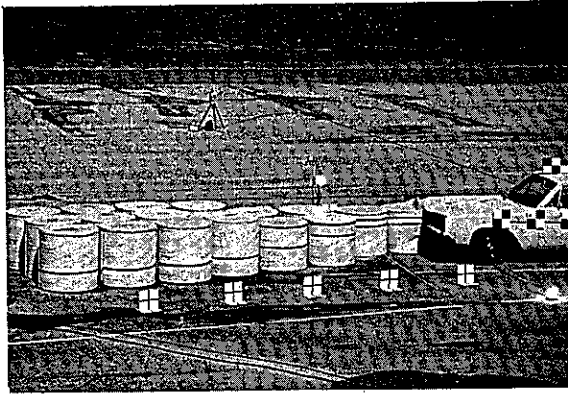
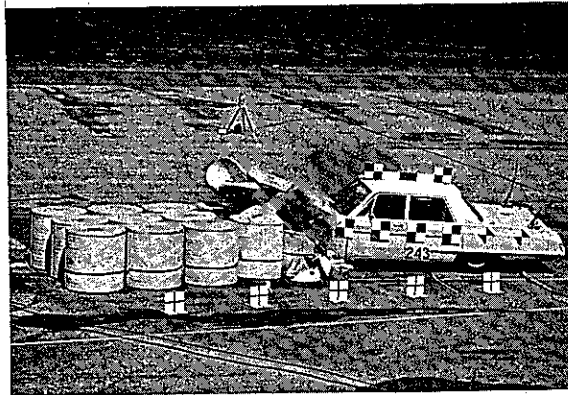
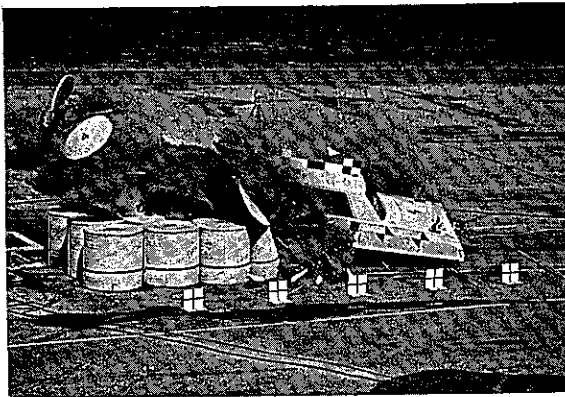
See Plate 7, page 26, for a summary of the test results. The crash vehicle hit the nose of the barrier about a foot to the right of the planned point of impact at a speed of 57 mph and angle of 15° with the barrier axis. It ramped up midway into the barrier and continued on over and through it, narrowly passed by the right corner of the Type 8 bridge approach guardrail nose, and stopped

Test No. 243
Date of Test September 24, 1970
Vehicle 1968 Dodge
Vehicle Weight 4770 lbs.
(w/dummy & instrumentation)
Impact Velocity (V_0) 57 mph
Impact Angle 15° nose
Dummy Restraint Lap belt
Barrier Depth 25'-3"
No. of Plastic Barrels 17

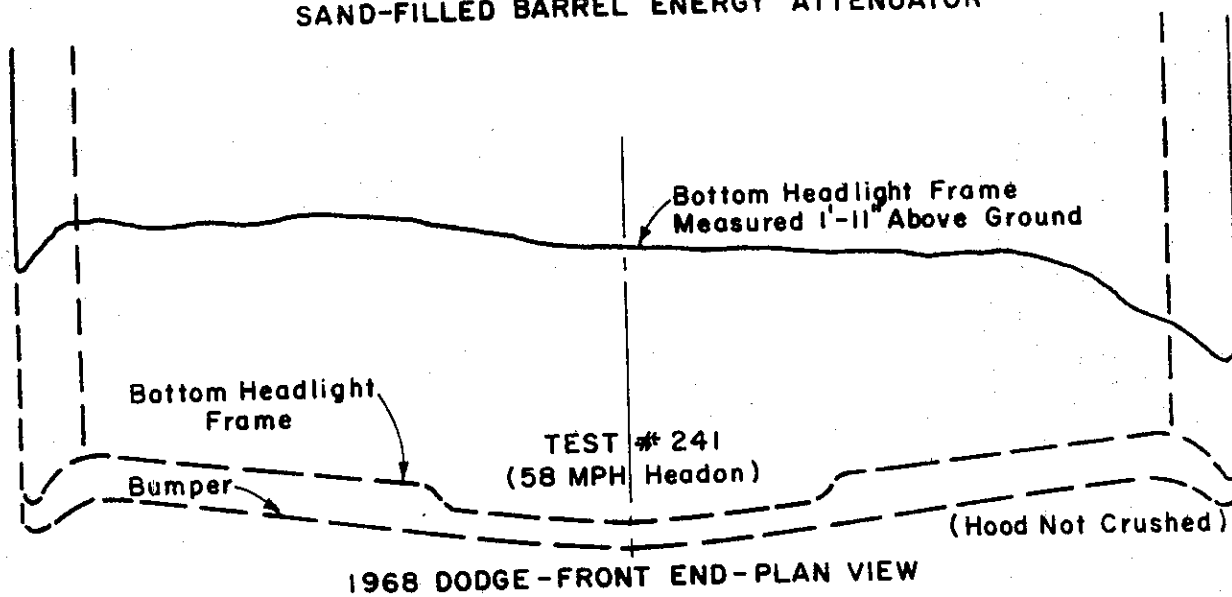
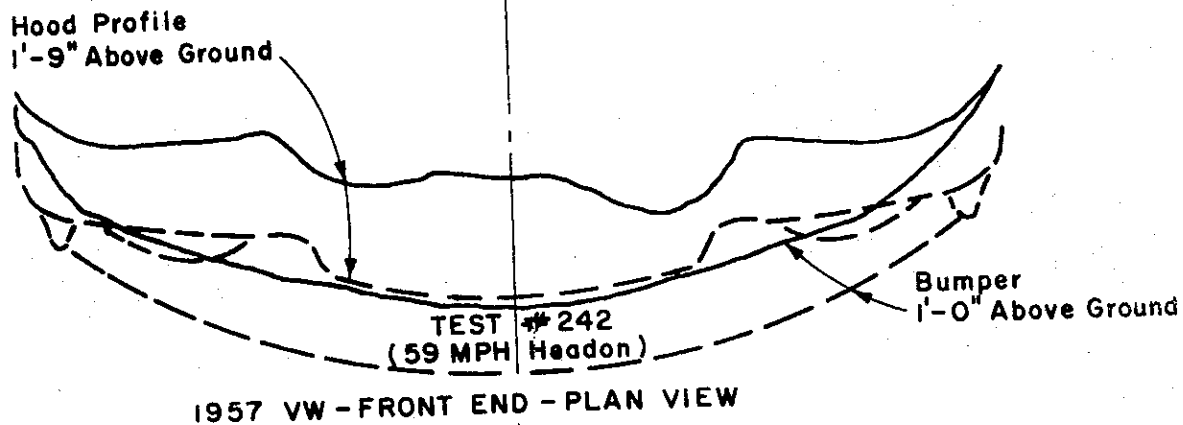
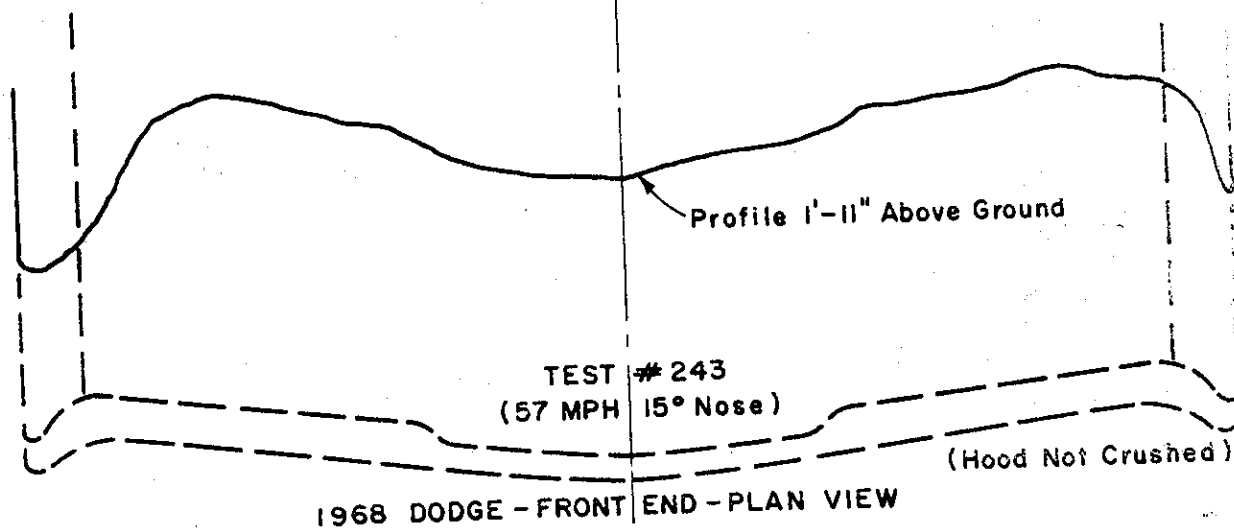
VEHICULAR CRUSH SAND-FILLED BARREL ENERGY ATTENUATOR

Damage was confined mainly to the front end. Maximum significant crush at the center of the vehicle forestructure was 1'-8". The crush was fairly uniform across the front of the vehicle but slightly less on the left side (see Figure 8 and Exhibit 3). The lower frame member, bumper, and front fenders were all severely buckled and the radiator was shoved back against the engine. On the passenger side, the front windshield was cracked where the sun visor came down and was struck by the dummy's head. No crimp in the roof over the doorpost was observed. The doorpost on the driver's side was torn loose from its roof connection and displaced back $\frac{1}{2}$ ". Immediately after impact, the hood flew open. However, it sustained no damage, mainly because the level of the hood was higher than the 2'-6" high barrels at the nose of the barrier. The steering wheel deformation was 2 $\frac{1}{2}$ "; the collapsible steering column was foreshortened 0.7" when the jackknifing dummy hit it.

Damage to the vehicle forestructure was quite severe (Figure 19). The front end, including fenders, was uniformly crushed back against the engine. The maximum crush was 1'-9" (Exhibit 3). The engine was not displaced. The lower longitudinal front frame members and the bumper were sharply buckled down to the ground and back against the front wheels. The hood was undamaged due to the relatively low 30 in. height of the first four rows of barrels. A

Dashed lines show precrash profiles.
